Investigation on crack propagation and crack branching in lightly reinforced concrete beams

Abstract - In concrete structures the various cracks in the building occur during construction and/or after completion. A building member like beam or column develops cracks whenever the stress in the member exceeds its strength. The Stress in the building members are caused by externally applied loads. The cracks in Reinforced Concrete Beams are essentially characterised by the principle reason, cause or mechanism related with the function of cracks. The basic aim of the project is to investigate the cracking process in lightly reinforced concrete beams. Till now relatively few fracture oriented experimental studies have been conducted on concrete members that are reinforced. In this experimental investigation the cracking process in lightly reinforced concrete (RC) beams analysed and investigated and to observe the details at localised fracture process zone development during the pre and post loading process using digital image correlation. More specifically the aims were to investigate the relationships between beam height (120 mm, 220 mm and 320 mm), steel reinforcement ratio (0.1 to 0.

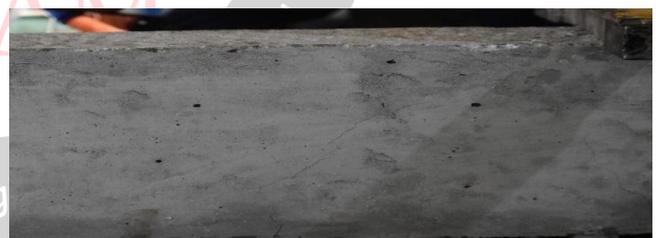
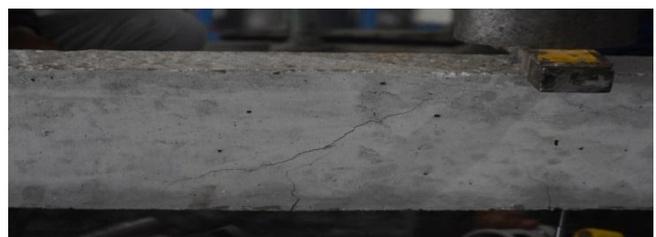
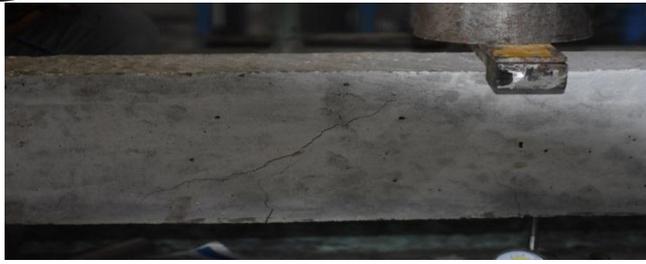
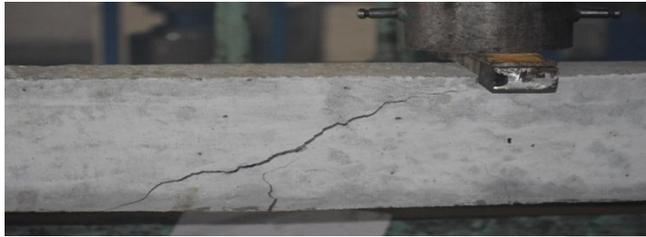
Fig 6.4 Crack Development of Beam M25,D180,0.5

Load 10KN

Load 16.5 KN

Load 18 kN

Load 15 kN

The crack initiation in beams is resisted by the presence of reinforcement. The reinforcement bridges the crack and exerts a force that opposes crack opening. In this section crack profile observations vs loads are analysed to investigate the fracture evolution in reinforced concrete. One unreinforced beam was tested in each series to establish the baseline concrete fracture properties. This helps to understand the effect of the reinforcement on the fracture behaviour of concrete. The unreinforced specimens failed due to a crack propagating from above the crack tip. For beam M25,D180,0.5 flexure crack is followed by diagonal crack. For this beam flexure crack occurs below 10KN and diagonal crack occurs at 10KN. At 16.5 KN the width of the diagonal crack increases significantly. The failure occurs approximately at 21KN as load suddenly falls from 21KN to 20.5KN.

For beam M25,D230,0.3 the onset of cracking occurs at 5KN which propagates vertically at around mid span. For this flexure crack, width tends to increase until crack branching takes place at approximately 15KN. The failure approximately occurs between 16KN and 17KN. If we compare beam M25,D180,0.5 and M25,D230,0.3 ,the reinforcement has predominant effect on the ultimate strength of beams. Although Beam 2 has higher effective depth the Beam 1 fails after beam 2 having higher reinforcement ratio.

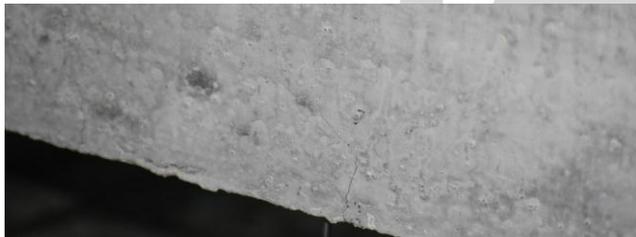
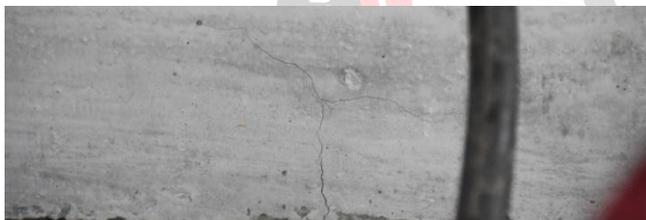
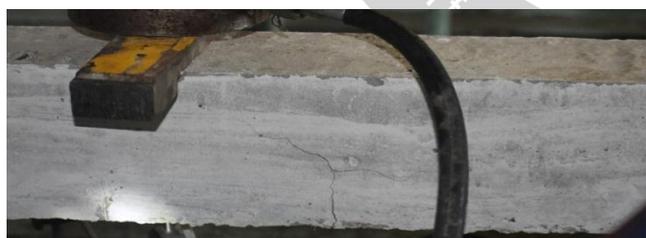
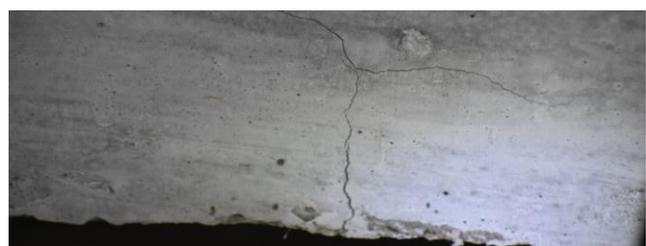
Fig 6.5 Crack Development of Beam M25,D230,0.3

Load 5kN

Load 15kN

Load 19kN

Load 17kN

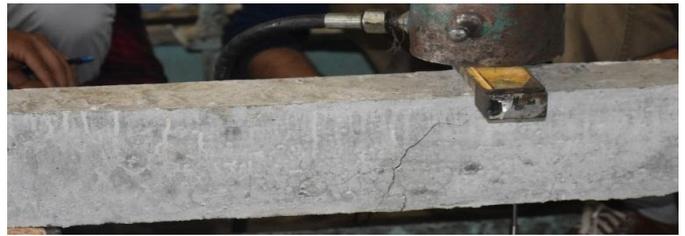
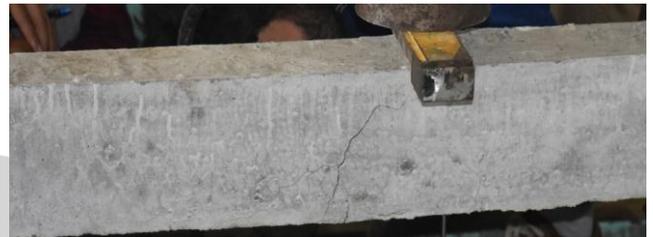
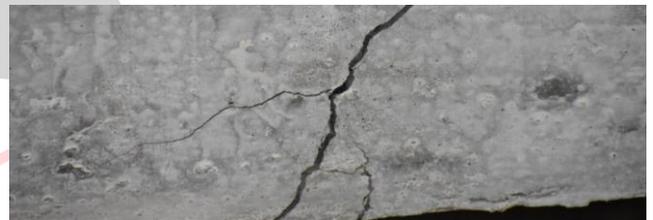
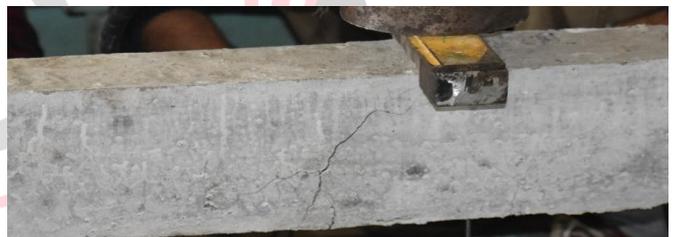
Fig 6.6 Crack Development of Beam M30,230,0.5

Load 17kN

Load 20kN

Load 29kN

Load 25 kN

For Beam 3 i.e MM30,D230,0.5 th crack starts to propagate at approximately 15KN. The branching starts at an load between 15 KN and 17KN. The crack width increases significantly after 20KN until 29KN at which Failure takes place. This type of failure may be attributed to shear bond failure or combined effect of shear and bond. For Beam M25,D180,0.3 the crack initiates at 10KN vertically upwards indicating pure flexure failure. The crack tends to propagate until 14KN and beam ultimately fails at 15KN. Comparing beam M25,D180,0.5 and M25,D180,0.3 we see that ultimate strength is increased by increasing reinforcement ratio keeping the effective depth same. It can also been seen that reinforcement prevents crack propagation upto certain limit after which sudden failure can occur without giving ample deflection For Beam MM30,D230,0 the beam starts to show cracks at 7KN after which crack tends to grow up vertically upto 10KN. At 5KN the beam fluctuates the vertical path and bends at small angle. The beam ultimately fails at 13KN. This deviation from path may be attributed to heterogeneity of the material and aggregate interlock

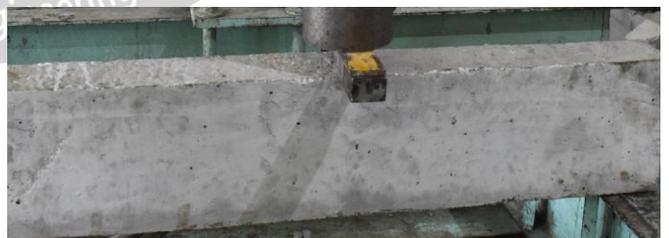
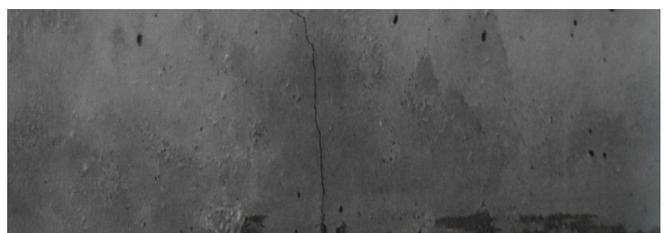
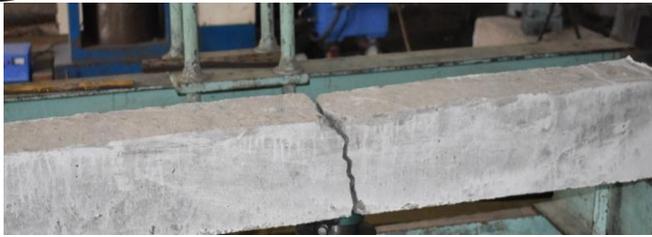
Fig 6.7 Crack Development of Beam M25,D180,0.3

Load 8kN

Load 12kN

Load 15K

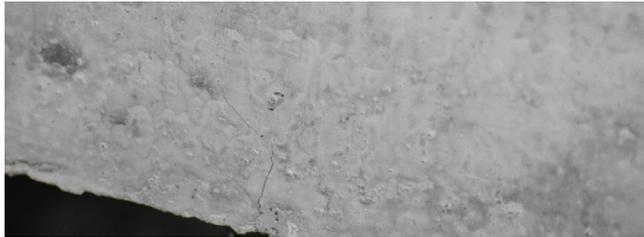
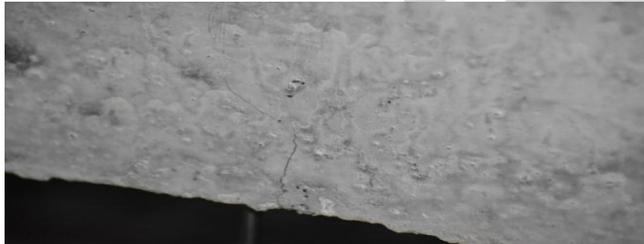
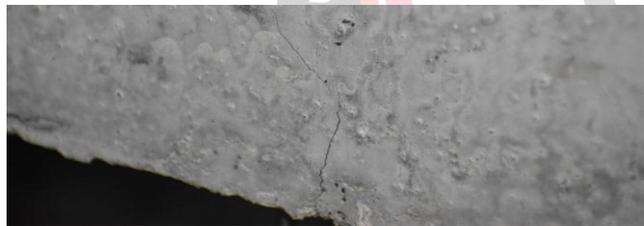
Fig 6.8 Crack Development of Beam M30,D230,0

Load 3KN

Load 5KN

Load 6KN

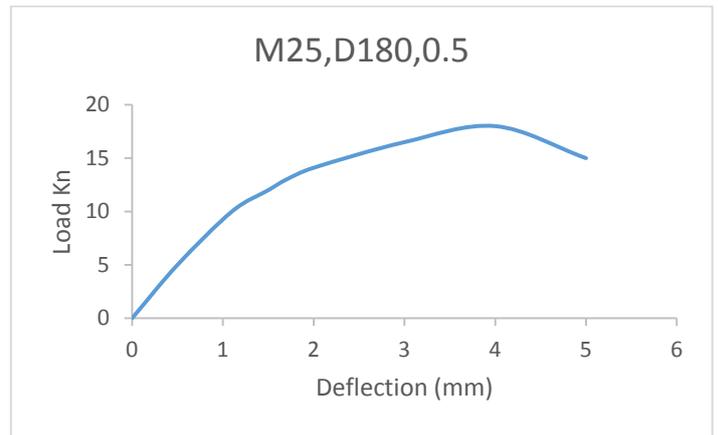
Fig 6.9 Load Deflection Curve of Beam M25,D180,0.

LOAD (KN)	0	5	10	12	14.1	16.5	18	15
DEFLECTION (MM)	0	0.5	1.1	1.5	1.7	2	3	3.5

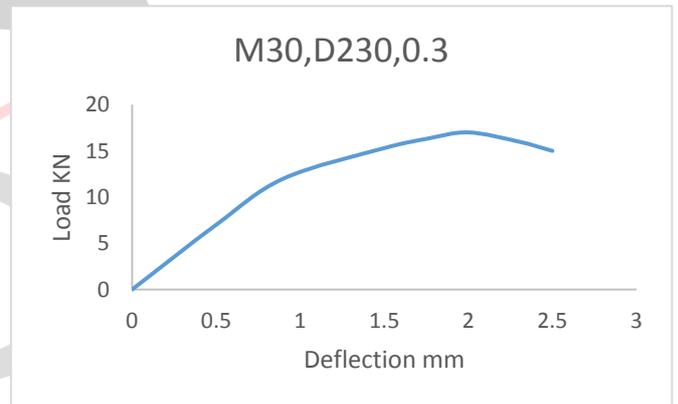
Fig 6.10 Load Deflection Curve of Beam M30,D230,0.3

LOAD (KN)	0	7	12	15.3	16.3	17	16	15
DEFLECTION(MM)	0	0.5	0.9	1.5	1.75	2	2.3	2.5

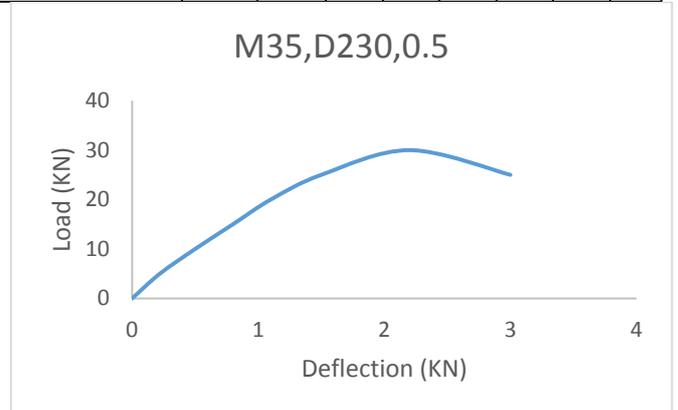
Fig 6.11 Load Deflection Curve of Beam

LOAD (KN)	0	5	10	15	20	25	30	25
DEFLECTION (MM)	0	0.22	0.5	0.8	1.1	1.5	2.2	3

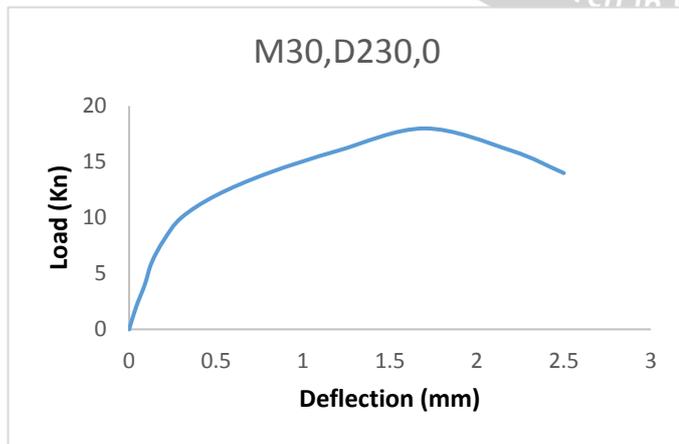
Fig 6.13 Load Deflection Curve of Beam M30,230,0

LOAD (KN)	0	2	4	6	8	10	12	14	16	18	20
DEFLECTION (MM)	0	0.04	0.09	0.13	0.17	0.21	0.25	0.29	0.33	0.37	0.41
