Assessment of Pavement Surface Defects & Its Mitigation Measures: Case Study of Hawassa City, Ethiopia

Abstract – This paper will visually inspect and evaluate the flexible pavement failures and their causes as well as resolution methods. It is quite important to examine and identify the causes of the failed pavement to select a proper treatment option. The study consisted of two tasks: the first covers the visual inspection of the existing pavement failures, whereas the second investigates the actual causes of these failures. As a case study, Hawassa city main road from Hawassa University main gate to Monopole was selected for investigation. An intensive field work was carried out on the existing pavement condition of this road. It was found that most of the damaged pavement sections suffered from severe cracking, potholes and raveling failures. These failures might have been caused by fatigue failures on pavement structure due to the movement of heavily loaded truck - trailers. The damage could also be attributed to poor drainage, inadequate design and improper pavement materials use.

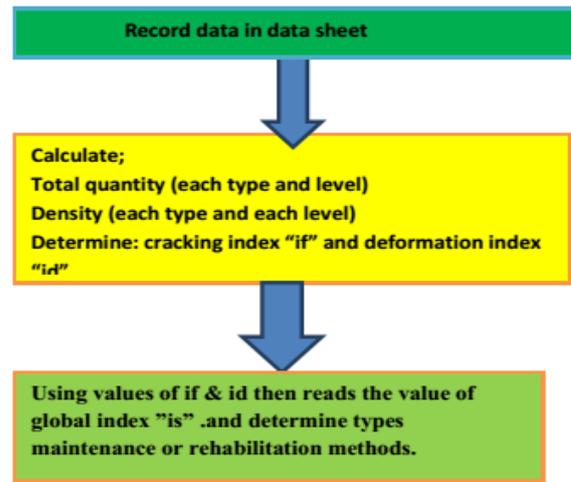
Figure 1 Flow Chart of Data Analysis

The data analysis consists of classification and quantification of distresses so as to identify causes of distress and propose possible maintenance options.

- i) **Classification of distresses:** Classify the type of distresses into possible causes such as load associated, climate/durability associated and moisture/drainage associated distresses based on the results of the visual condition survey.
- ii) **Identify Probable Cause of Pavement distress:** The second stage in the data analysis is to establish causes of pavement distress by interpreting the data collected during the visual inspection of the site and other field investigations and from questioner.

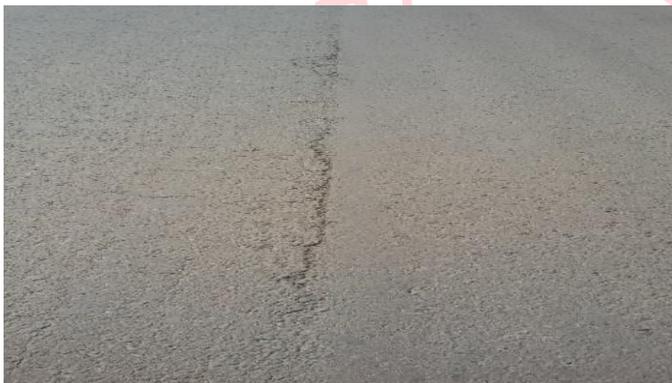
Figure 2 Longitudinal Cracks

From our observation longitudinal cracks which is parallel to the pavement's center line and lay down direction is clearly exist.

Allows moisture infiltration, roughness, indicates possible onset of alligator cracking and structural failure.

Pavement that is fatigue or "worn out" from heavy traffic especially that due to high pressure truck tires; an unstable base; poor Construction [8].

Also treatment these cracks depend on the severity and intensity. In the case of low severity nothing is there but in the medium severity resort to fill the cracks. In the case of high severity use overlays surface, or implementing to thin overlay.

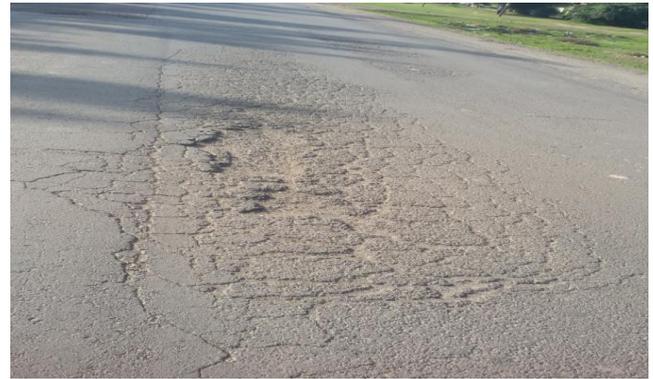
Figure 3 Alligator/Fatigue Cracks

In our study Alligator Cracking begins at the bottom of the asphalt surface (or stabilized base) where tensile stress and strain are highest under a wheel load. The cracks propagate to the surface in all direction equally.

Indicator of structural failure, cracks allow moisture infiltration, roughness, may further deteriorate to a pothole.

Repeated traffic loading, poor materials used in pavement, insufficient thickness of the pavement and poor drainage.

Treatment based on the severity and intensity of cracks starting using overlays, surface patching or re-construction.

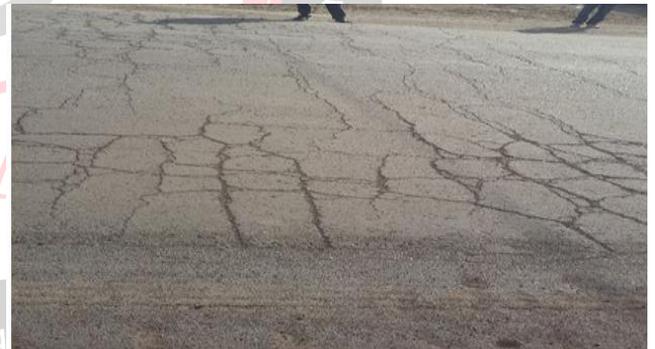
Figure 4 Blocking Crack

These types of cracking are interconnected cracks that divide the pavement up into rectangular Pieces. In our cases block cracking normally occurs over a large portion of pavement area but sometimes will occur only in non-traffic areas).

a. Problem - Allows moisture infiltration and roughness effect

Typically caused by an inability of asphalt binder to expand and contract with Temperature cycles because of: Asphalt binder aging, poor choice of asphalt binder in the mix design [11].

Treatment based on the severity and intensity of cracks starting using overlays, surface patching or re-construction.

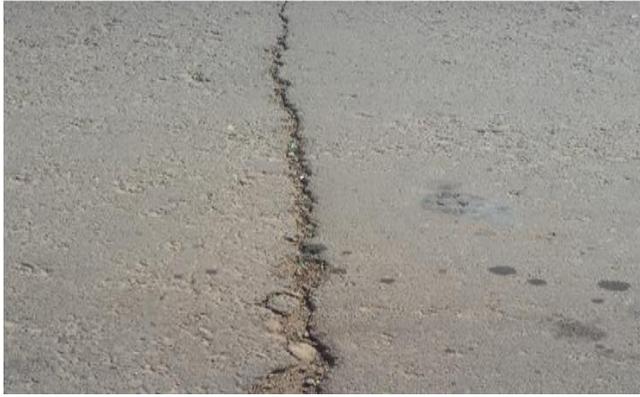
Figure 5 Transverse cracks

The selected road section transverse cracks extend across the pavement at approximately right angles to the pavement centerline or lay down direction.

Allows moisture infiltration, roughness

Shrinkage of the pavement surface due to low temperatures or asphalt binder hardening. Reflective crack caused by cracks beneath the surface layer.

Treatments to these cracks depend on the severity and intensity. In the case of low severity, doing something in

the medium severity resort to fill the cracks leads to worse. In the case of high severity use overlays surface, or implementing to thin overlay.

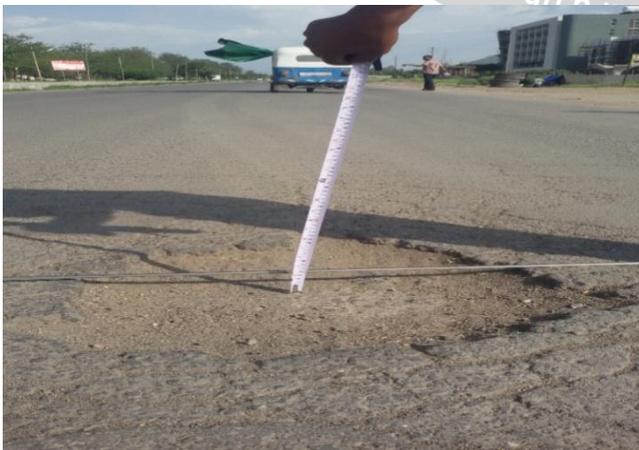
Fig. 6 Pothole

Pothole defects are not widely observable in this road section. But some of them generally have sharp edges and vertical sides near the top of the hole [7].

Roughness (serious vehicular damage can result from driving across potholes at higher speeds), moisture infiltration.

Generally, potholes are the end result of alligator cracking. As alligator cracks become severe, the interconnected cracks create small chunks of pavement, which can be dislodged as vehicles drive over them. The remaining hole after the pavement chunk is dislodged is called a pothole.

The treatments are surface patching or deep depend on depth of the hole. No matter what cure is chosen, it is important to fix the situation which caused the pothole.

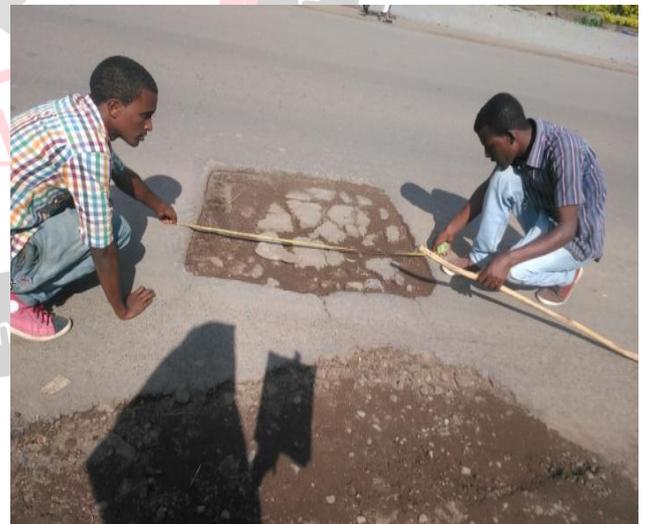
Fig. 6 Depression

Depressions are also other pavement surface defects with elevations slightly lower than those of the surrounding pavement. This occurs severally in road section. In many instances, light depressions are not noticeable until after a rain, when ponding water creates a "birdbath" area; on dry pavement. It is created by settlement of the foundation soil or a result of improper construction, causes roughness, and when deep enough or filled with water.

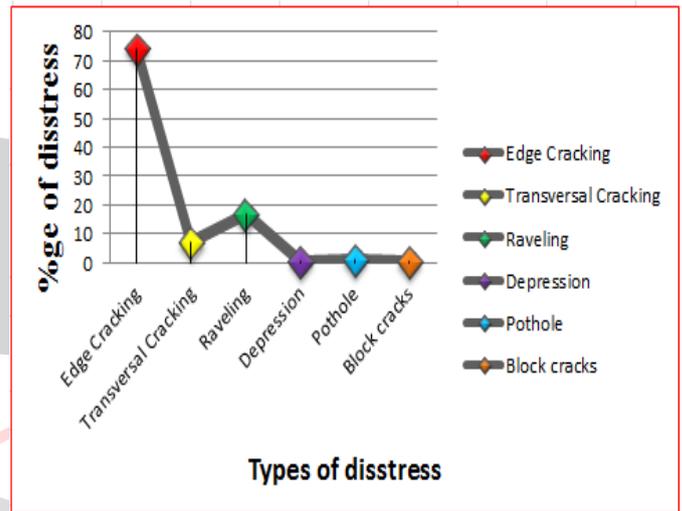
Figure 7 Graphical Representation of the Type of Distress

Distress Type	Total Distress Density	%age Distress Indicator
Edge Cracking	1682.8	74.31
Transversal Cracking	157.7	6.97
Raveling	383.2	16.93
Depression	11.1	0.49
Pothole	23	1.02
Block cracks	6	0.27
Total	2263.8	100

From 7 Graphical representations the majority of the road is affected by edge cracking. Next to edge cracking raveling is dominates the other.
