Risk Analysis Report of 178 years old Railway Bridge

¹Er. Parvinder Singh, ²Er. Ishu Jindal, ³Er. Mohit K. Garg

¹Structure Engineer, ^{2,3}Managing Director, Buildtech Engineers, Bathinda, Punjab, India,

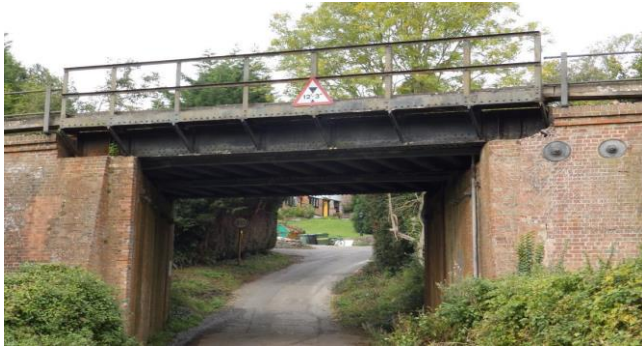
Fig. 1. The Barming Railway Bridge

Structural Details: - The construction of this Railway Bridge was completed in 1844. This bridge form is a common type of design for railway bridges of this age. The structural form comprises of three I-girder beams, fabricated from wrought iron, riveted together with angle plates to form single girders.

The three I-girders bear down on six pad-stones which are used to distribute and transfer the vertical compressive loads to the abutment wall. The deck spans laterally between the I-girder beams and they are made from riveted cross girders fabricated from plates and metal troughs. The troughs are made from rolled steel and bear on an angle plate which is riveted to the corners of the main I-girder beam. The adjacent troughs are interconnected by a riveted joining plate. Angle cleats are riveted to the top of the connecting plate and also riveted to the web of the main I-girder beam. The troughs may be infilled with concrete with a ballasted track on top supporting railway line.

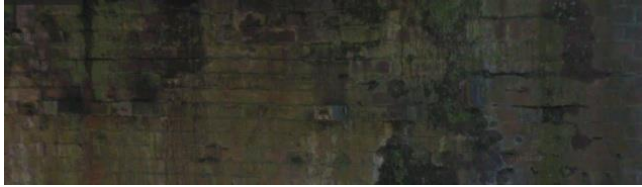
Fig. 4. Longitudinal Cracks

Longitudinal cracks are likely to be on outgoing plane. These types of cracks can be happen shortly after the construction of bridge elements. There are two main reasons for the development of the cracks in bridge.

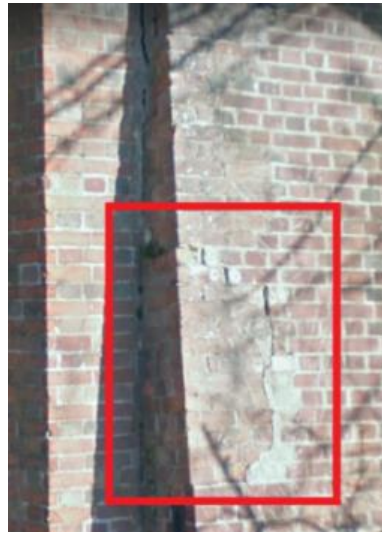
Fig. 6. Stepped Cracking & ongoing Maintenance

2. Stepped Cracks: - As the name defines these are the cracks which develops in the form of steps. These cracks looks like stairs going up and down these cracks usually seen in the foundation area which is sinking or settling due to any reason. Stair step cracks develop usually in brick masonry. In Brick masonry the main causes of these cracks is uneven moisture & relative settlement of the foundation. Evidences of routine maintenance can be detected, as there is color difference in the bricks and repointing of the cracks is detected.

According to the present condition, a regular inspection and repair is must be taken in account. If theses cracking will continue to expand risk of unstable settlement of the structure may arise. This settlement will further become a cause of derailment of the train passes through the bridge.

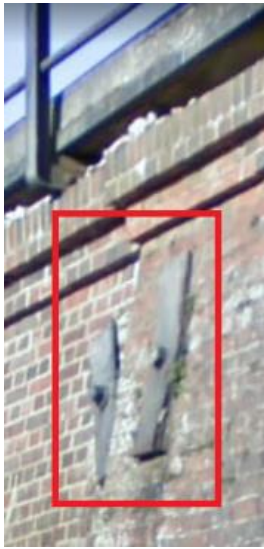
Fig. 7. Patress Plate Corrosion

Predicted Risks: - Patress plate are recessed into brickwork to reinforce it. If these plates get deteriorate the strength of the brickwork get reduce and the wall will compromise with stability.

In the present conditions, the Patress plates failure of the structure due to these risks is Unlikely, that means these represents low risk to the members of the structure. However, a proper remedial step is to be taken for the defect, otherwise the element will become a risk within one to two years.

Measures should be taken to avoid Corrosion:-

1. Pipeline Cooling.
2. Soil Corrosively.
3. Potential for stray Current.
4. Stress corrosion cracking potential.
5. Inspection of redefies and interference bonds.
6. Close interval survey.
7. Use of interval inspection tools.

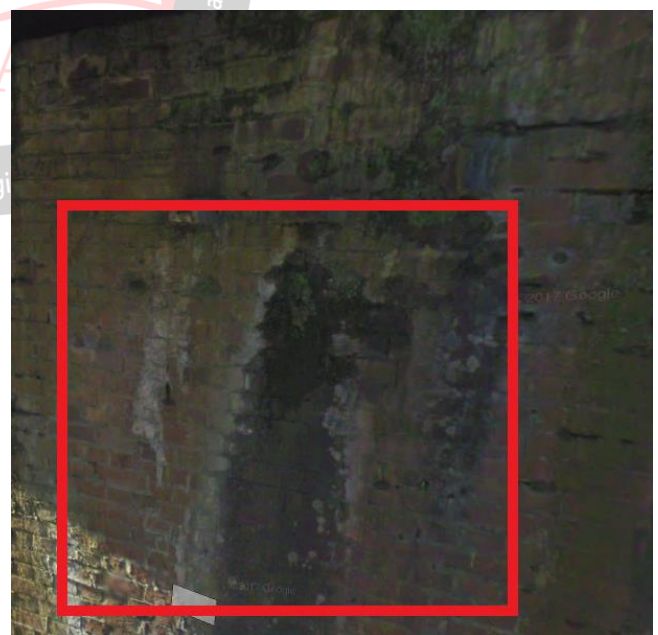
Fig. 8. Water Strains / Wet patches

Dampness is the presence of unwanted moisture in the structure of the building. Water seeping through brickwork is the major cause of the dampness in this bridge. The moisture will also penetrates to the foundation by means of the brick masonry of the bridge abutments.

In this bridge there are steel gully drains responsible for the carriage of the storm water through the bridge. Evidence are collected where there are damaged gullies which are also a factor due to which the corrosion of the material takes place.

1. Degraded Mortar: Due to continuous water seepage, combined acidic water dissolve calcium carbonate and mortar constituents, the degradation of the binding strength of the cement mortar initiates.

1. Selection of material with similar corrosive potential.
2. Breaking the electrical connection.
3. Applying coating to the materials.
4. Inserting a suitable sized spacer between two materials to separate them.

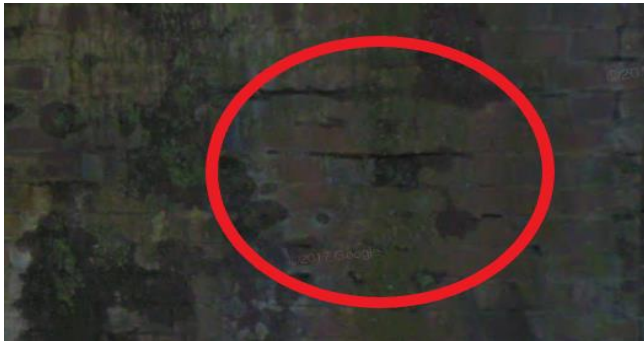
Fig. 9. Loose Brickwork

3. Loose Brickwork:- the Loose brickwork or spacing occurring the degradation of mortar which leaves to eventual loose through washout. (Fig. 9)

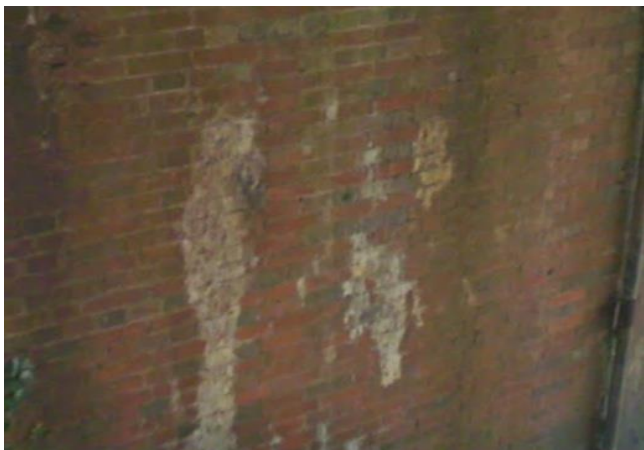
Fig. 10. Sulphate Attack Effects

4. Sulphate Attack:- The ground water contains sulphate. Acidic substance comes in contact of tri-calcium aluminate. The evidence of powdery white residue left behind on the lead to problem for cracks. (Fig. 10)

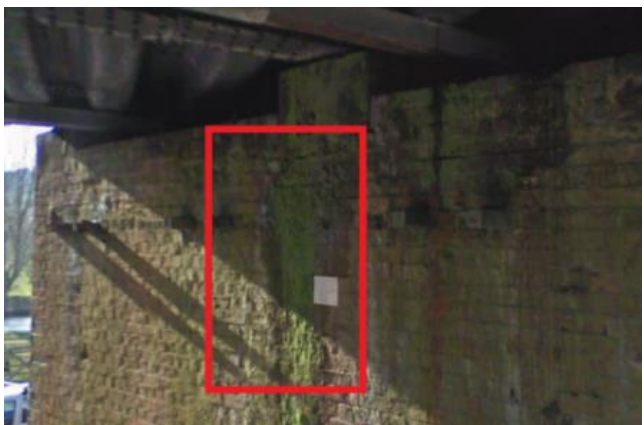
Fig. 11. Algae Growth

Weeding:- In brickwork the shrubs and algae growth will takes place in the brick joints. This will leads to loosen the joint. it's strength reduces and looks bad on the bridge structure.
