Failure Analysis of Drive Shaft

5. Case study

A drive shaft used in FSAE car of 20mm diameter and 320mm length is failed in running condition of vehicle. This brings us to do its failure analysis.

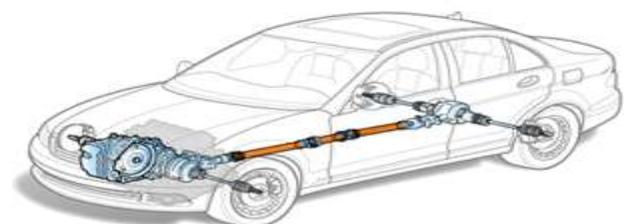
Location of drive shaft in vehicle

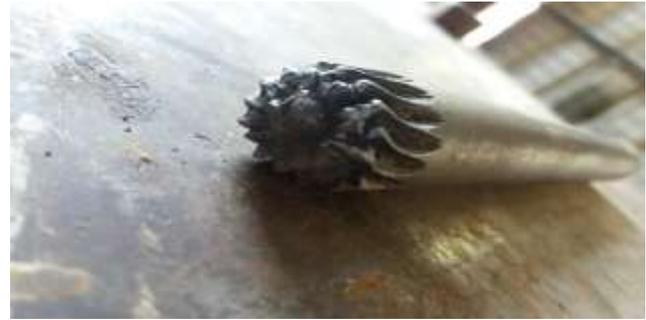
Failed drive shaft under running condition

- The drive shaft of 20mm diameter and 320mm in length is shear out from the splines.
- Do the failure analysis of the shaft
- Find the solution.

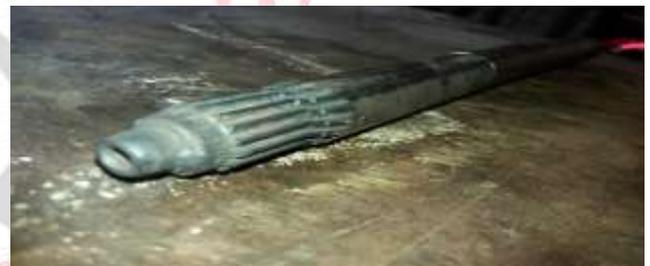
Drive shaft used in FSAE car

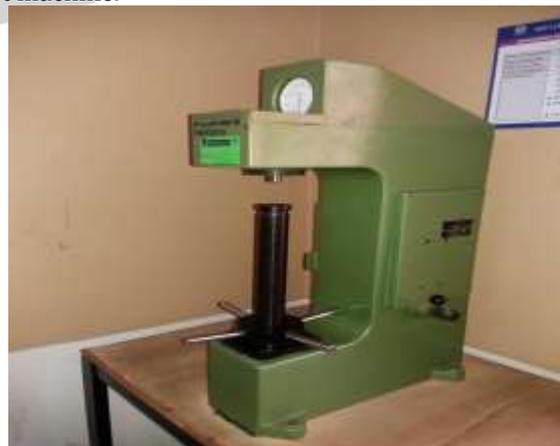
While analysis the problem it is found that the hardness of drive shaft is dropped because of normalizing. It is dropped up to the 17 HRC. It can be found by checking the hardness on Rockwell hardness test machine.

Rockwell hardness testing machine

The actual hardness of EN24 material is 26 HRC, but because of faulty heat treatment the hardness dropped to the 17 HRC, this is the main reason because of that the drive shaft is failed.

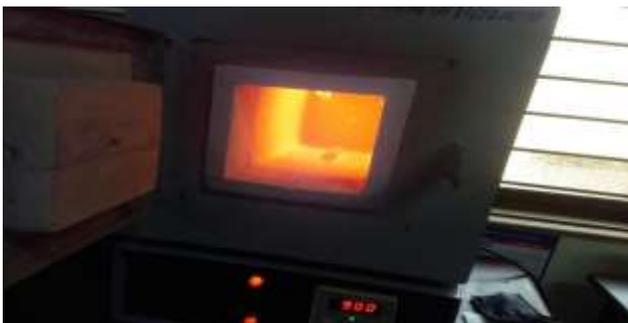
Muffle furnace

It is found that the problem with the drive shaft is dropping its hardness to the 17 HRC. Therefore with the proper and right heat treatment the hardness of the drive shaft can be raise. Hardening heat treatment which is followed by the tempering is done which gives 32HRC hardness. For any drive shaft it is important that the hardness should be in the range of 30 to 35 HRC. That can be achieved by hardening heat treatment

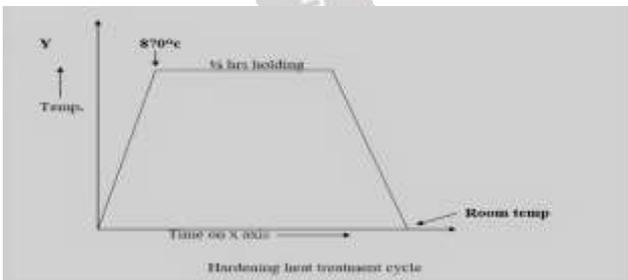
The heat treatment which is given to the failure part is hardening heat treatment. In this the part is firstly heated to its austenizing temperature at 880°C then that part is hold at this temperature for half an hour then the cooling is done in a water bath for high rate of cooling. This is required for martensitic formation. Now the hardness is 55HRC this hardness is reduces by high temperature tempering.

Hardening cycle

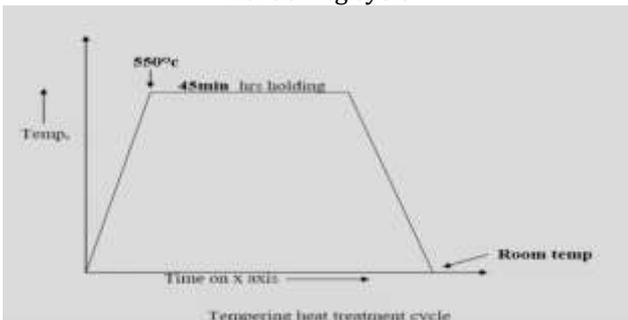
Tempering cycle

Although high hardness gives good wear resistance but, too much hardness is not applicable to drive shaft, because with increasing the hardness it also increases the brittleness of material. This is not the applicable in engineering filed.

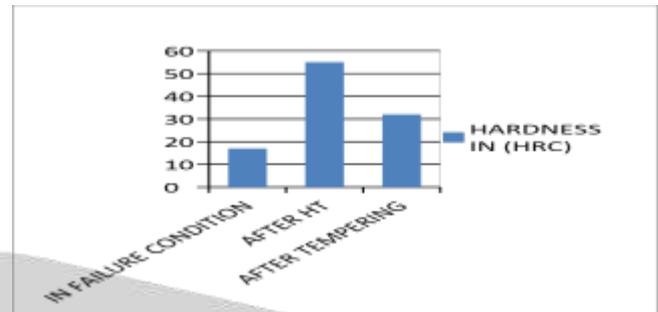
In this case study, the hardness is checked three times as shown in graph below,

Hardness variation with heat treatment

The hardness in initial case (in failure condition) is observed 17 HRC which is too low for drive shaft, and hence it is decided to do the hardening heat treatment to the drive shaft. This gives the hardness value of 55 HRC, this hardness value after the hardening process is too high because it is increasing the brittleness also. And after the tempering the hardness is drooped to the 32 HRC which is required to the drive shaft.

The drive shaft with 17HRC was failed in first 90 laps in our design track. This shows very bad result. Then it was decided to do heat treatment (hardening followed by tempering) which is mentioned above and put the drive shaft in safe zone with 35HRC at surface, And this drive shaft ran approximate 320 laps on the same track.
