# Thermography in Construction Industry.

**Abstract - Infrared Thermography is a modern non destructive measuring method which helps in defining faulty works in electrical connection, Thermal power plants as well as in medical field as it uses to identify temperature. Introducing this new technology in construction industry for water leakage source detection as well as the inspection work before hand over or possession and maintenance work of the flats.**

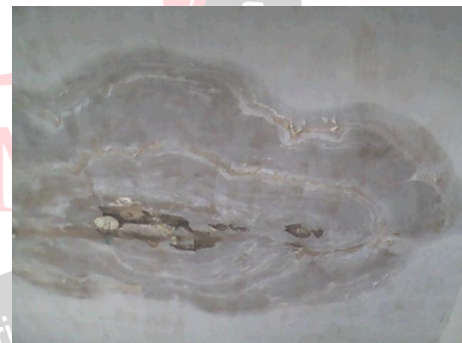
Fig no (1) Digital Image.

1) Let's assume this as flat number 102 the sealing dampness which we can see took place in the master bedroom of this flat which is clearly visible in digital image and the water which is stagnant in the slab is visible in thermal image. To find the source of this ceiling dampness thermography test has been carried out in flat number 202 after the thermography test was carried out the source which was detected was due to the water getting stagnant near door frame in master bathroom which was percolating through the open joints of door frame and tile the grouting which was done got washed away and all the water was seeping through these gaps and it got stagnant at that one point which was visible in flat number 102. So the conclusion which was provided is to fill those gaps with epoxy grout and avoid stagnation of water at that door frame.

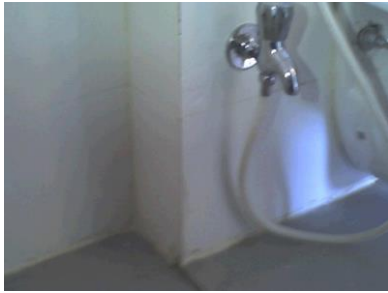
Fig no (3) Digital Image.

2) Assume this as flat number 203, as we can see in digital image that this is a health faucet tap in a bathroom. The water is coming out from the joint which is inside the tile

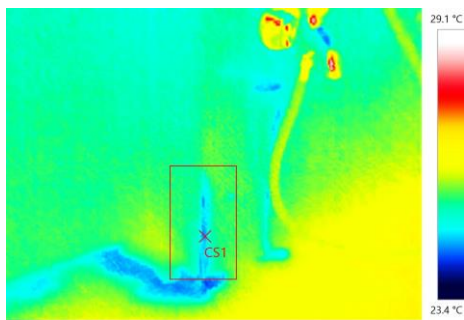
Fig no (4) Thermal Image

and is not visible in digital image and to the naked eye but with the help of thermal image we are easily able to see the exact source of leakage as there is this continuous source of water and water is continuously coming out from this tap internally and is traveling from inside the ledge wall which is seeping through the slab and affecting it. This major flow of water is causing a severe damage which is reflected in the flat below (i.e. in flat no 103) in the form of dripping. Such kind of major leakages which may affect the physical strength as well as the aesthetics of the flat are sometimes difficult to find out and this is where thermography helps.
